Final Report

MOSS LANDING POWER PLANT OFFSITE MITIGATION IMPLEMENTATION AT DOLAN RANCH, MOSS LANDING, CA

May 15, 2016

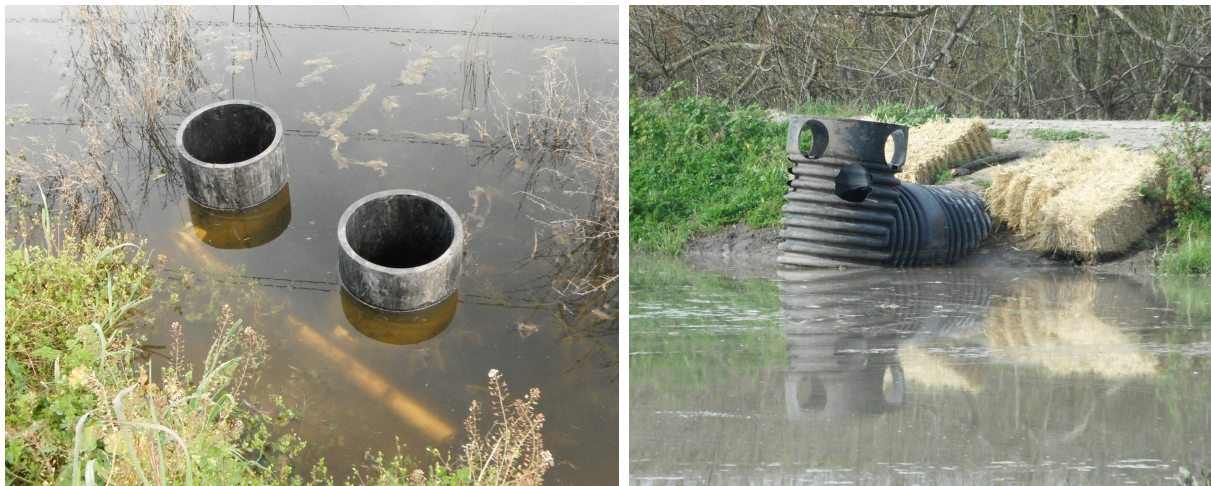
FIGURE 3. CULVERTS INSTALLED AT SOUTH FINGER MITIGATION SITE FOR WATER CONTROL. LEFT PANEL IS AT THE WEST END OF THE SITE WHERE IT DUMPS INTO MORO COJO SLOUGH. RIGHT PANEL IS AT THE SEDIMENT BASIN ON THE EAST END OF THE SITE.

No modifications were made to the North Finger site in terms of landforms and hydrology. Modification of the South Finger site occurred in 2011. At that time a sediment basin was created on the east end of the site to act as a receiving basin for agricultural run-off in which water flows would be slowed so that sediment could settle out before the water entered the wetland area to the east. Two roads were elevated and culvert systems were installed. One culvert runs under the road between the sediment basin and the westernmost edge of the wetland-willow habitat, to allow retention time and allow the sediment to settle before the water goes into the wetland. Another culvert system was installed on the eastern end of the wetland to allow retention of water in the wetland until just before it starts to flow over the road and then will pass under the road and enter into the Moro Cojo. Both culverts were installed at an elevation that prevents the roads that they pass under from flooding (Figure 3).

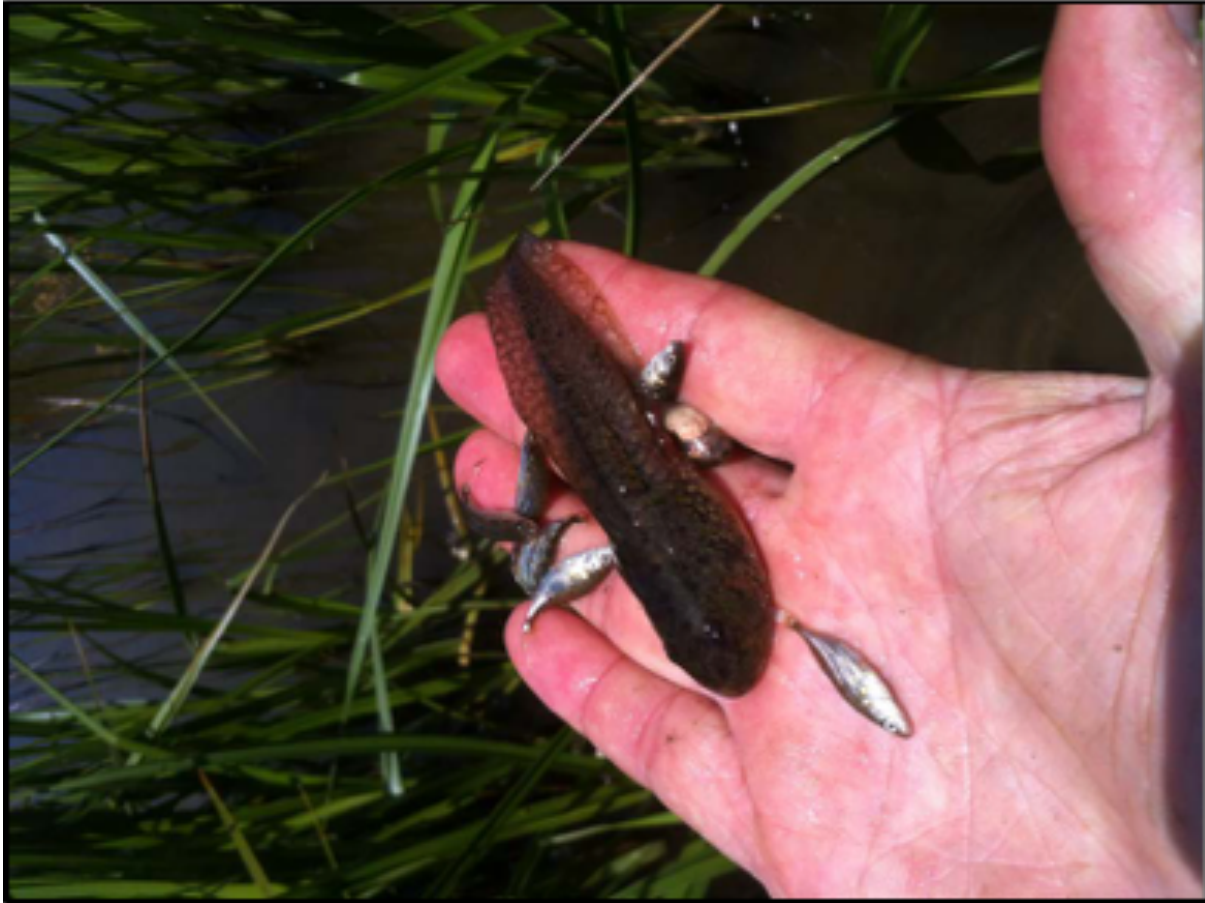
FIGURE 13. CALIFORNIA RED-LEGGED FROG TADPOLE CAPTURED IN A MINNOW TRAP IN SOUTH FINGER. ALSO PRESENT IN THE PHOTO ARE STICKLEBACK FISHES AND A PACIFIC CHORUS FROG TADPOLE.

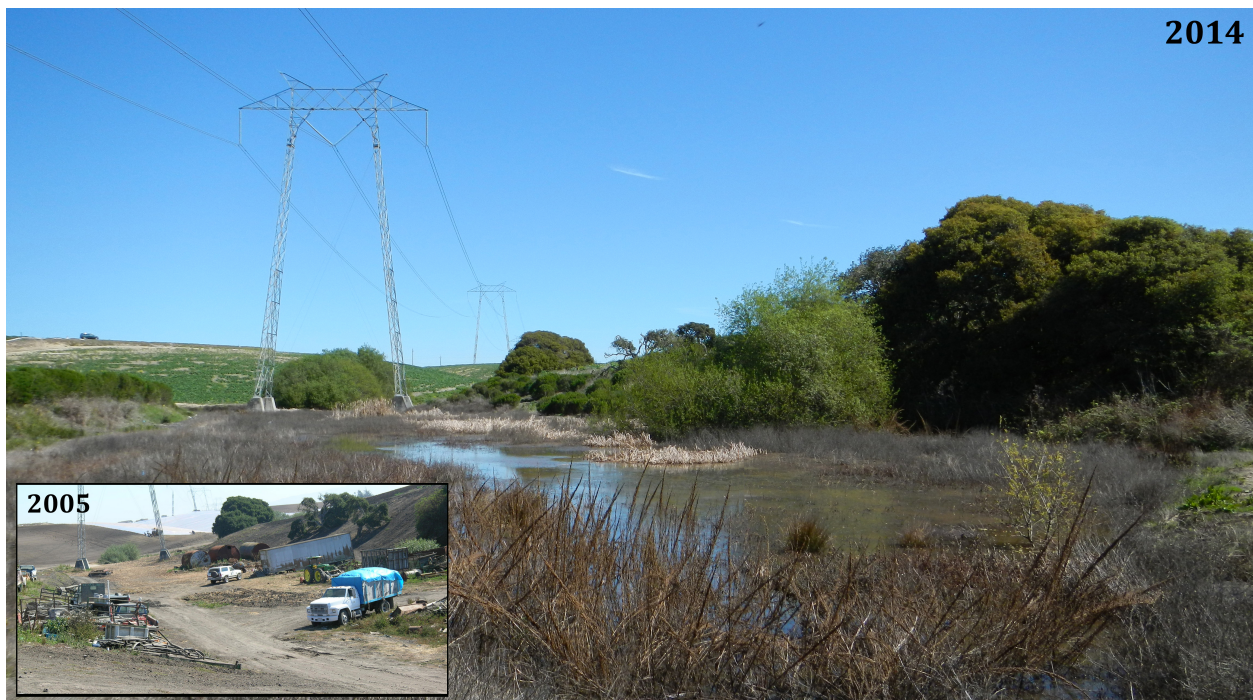
FIGURE 15. SOUTH FINGER MITIGATION SITE IN 2014, WITH THE ORIGINAL CONDITION IN 2005 (INSET).

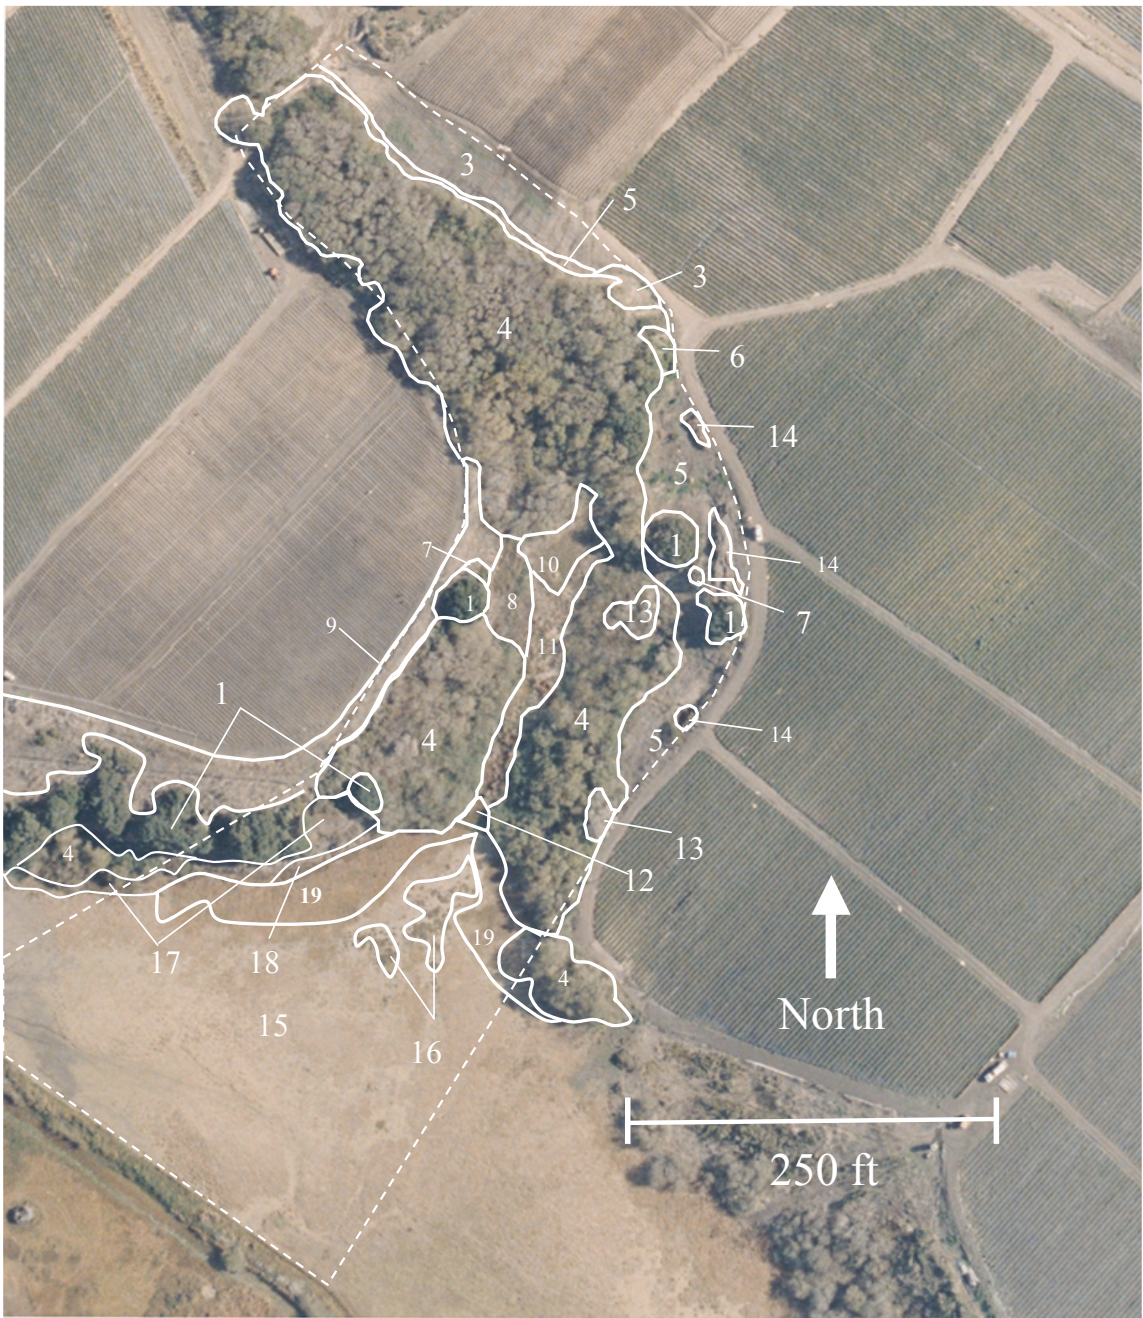
Figure 5: North Finger Vegetation Map (# refer to plant species found on table 2)

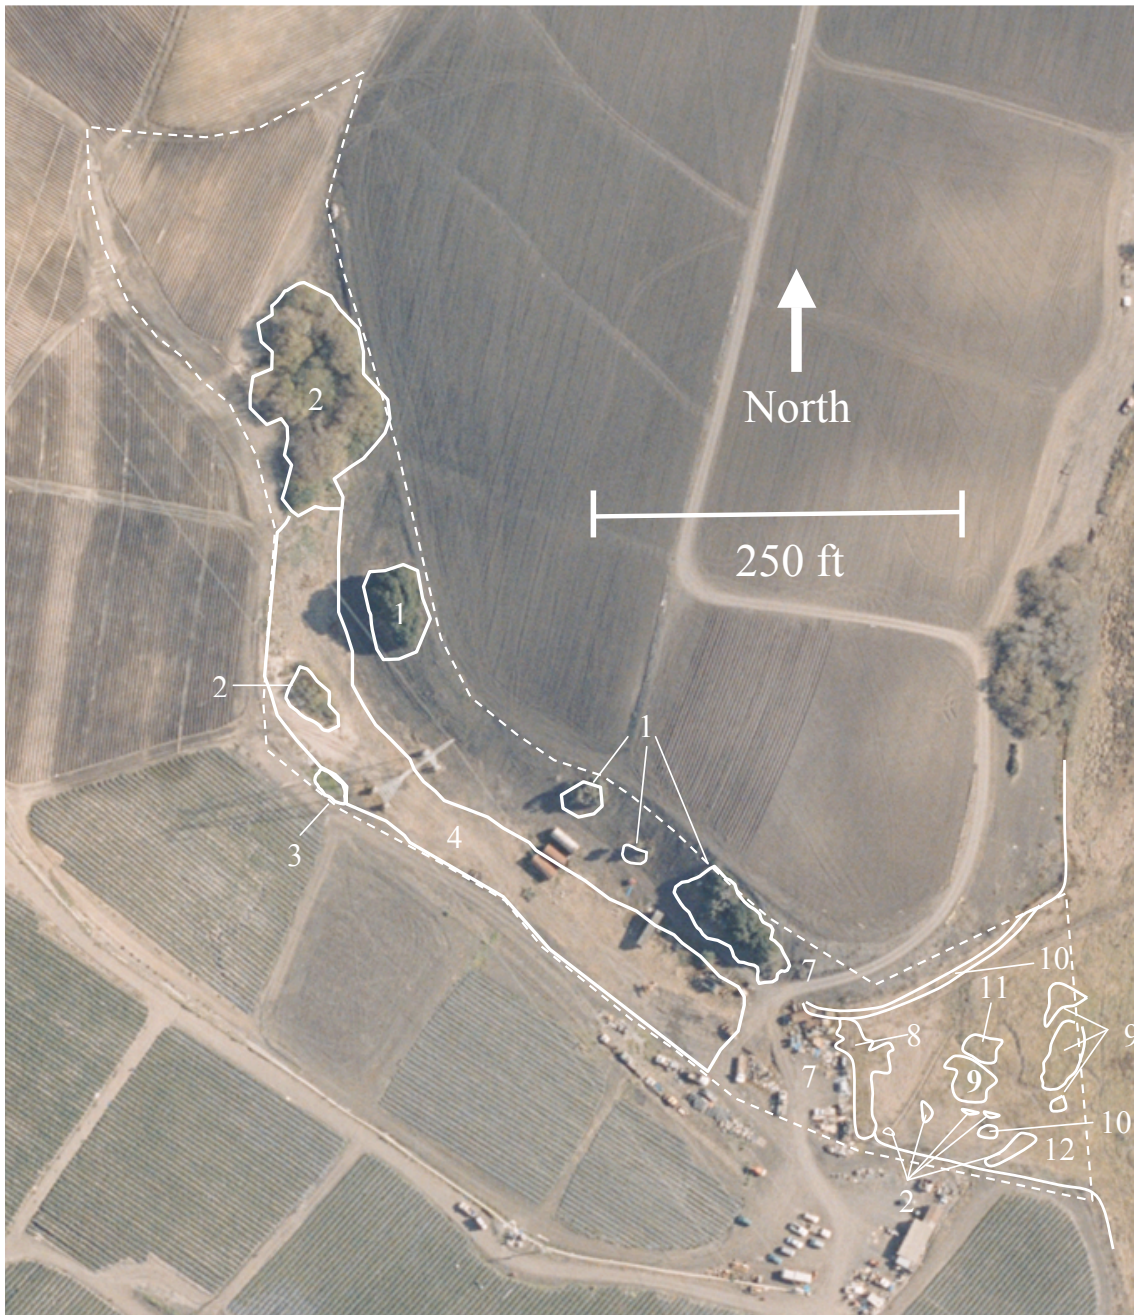
Figure 6: South Finger Vegetation Map (# refer to plant species found on table 2)

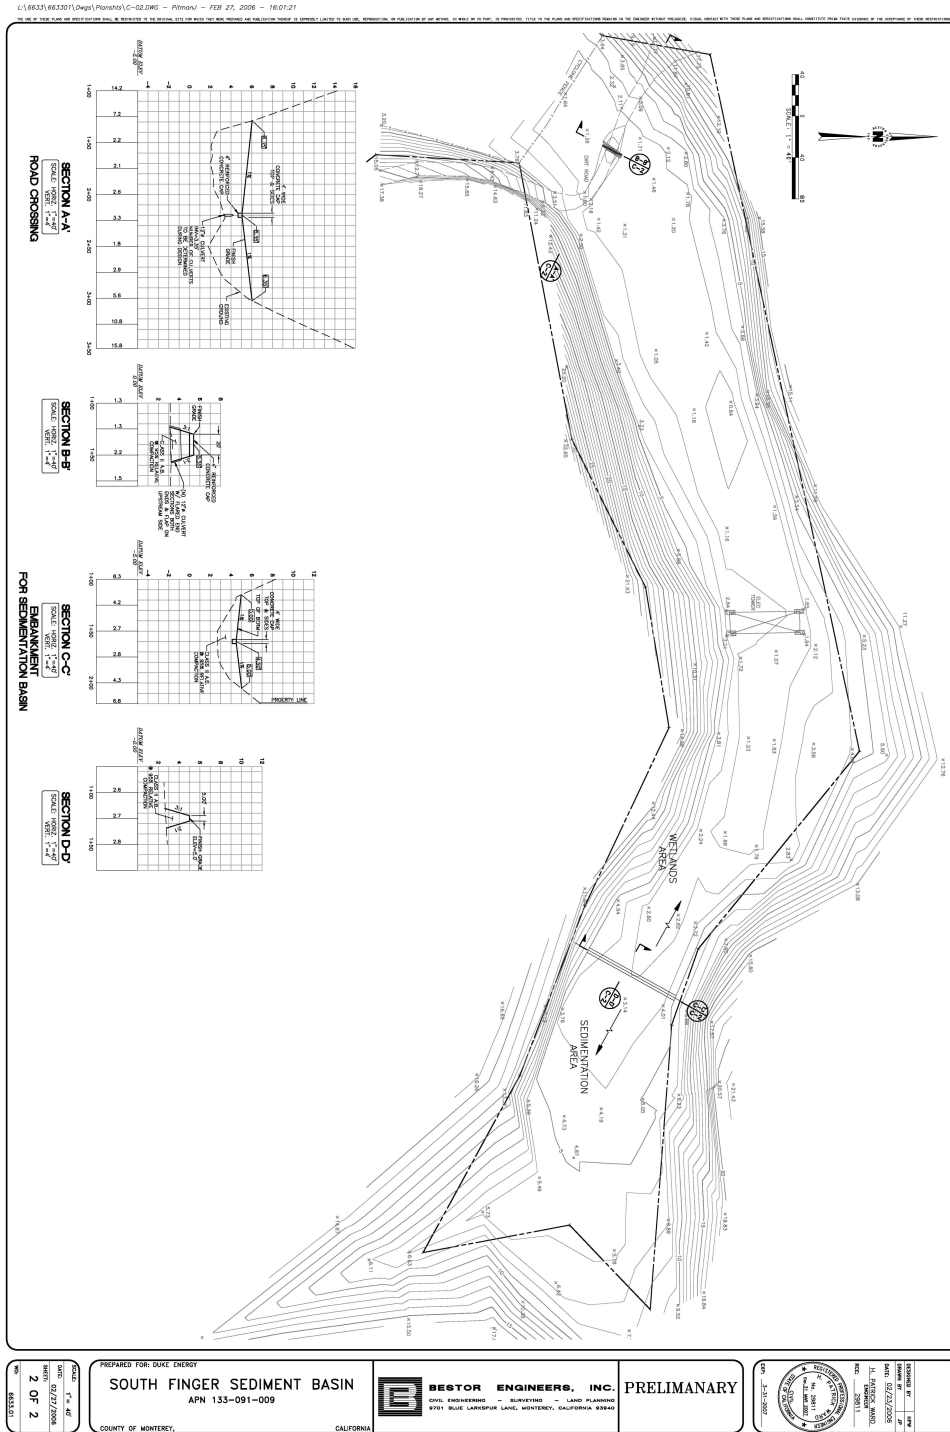
Figure 8 South Finger road and sediment basin
